THE VULNERABILITY OF ROTTING MARINE STRUCTURES TO IGNITION BY DISCARDED CIGARETTES (THE 2003 SATURNA ISLAND WHARF FIRE)

Richard van Leeuwen PEng
van Leeuwen and Associates

Michael Fitz, PE
President and Principal, MDE Inc, Seattle, WA

Presented at the
13th International Fire and Materials Conference
2013 January 28 – 30
San Francisco, USA

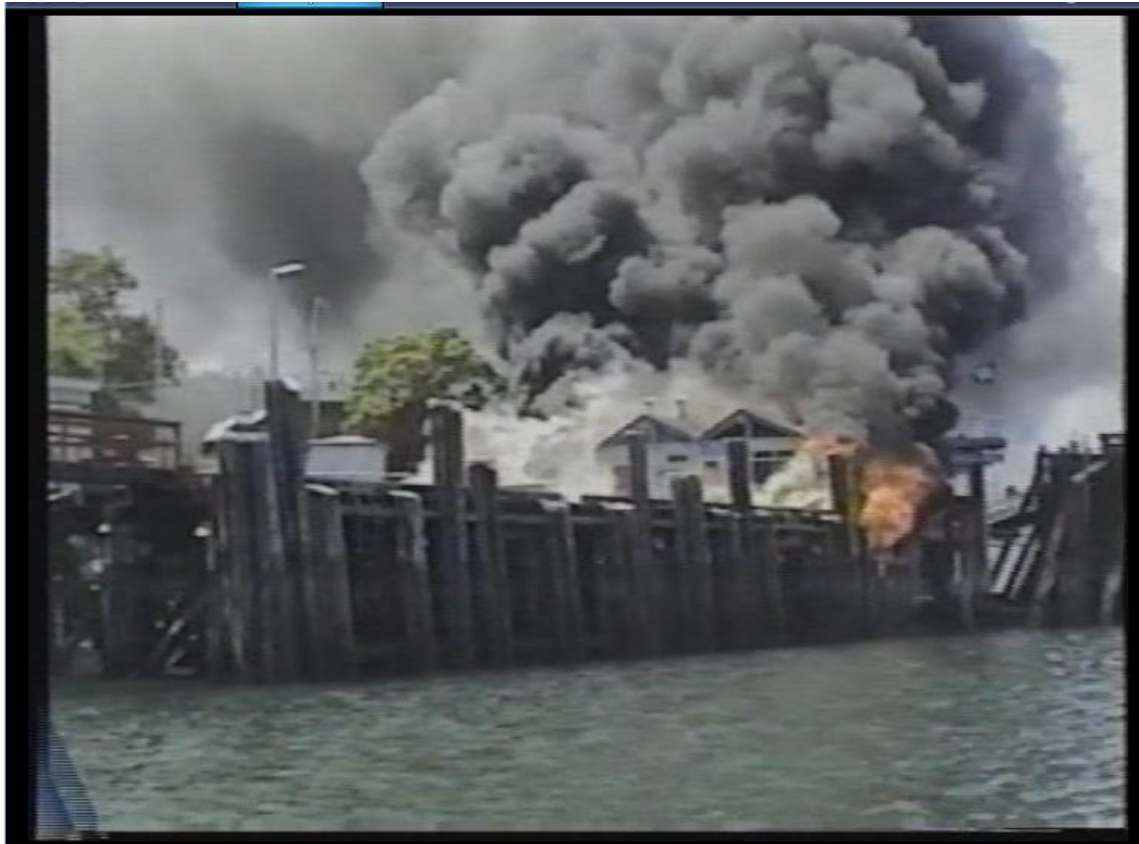
Figure 1

A large fire consumed most of the Saturna Island wharf and the neighboring BC Ferries waiting room on June 5 of 2003 (Figure 1). The fire was witnessed by several patrons of a nearby pub. The intensity of the fire presented difficulties for the local fire fighters, since the wharf was constructed of creosote saturated wood and the fire was beneath the structure.

It appeared to all investigators and witnesses that the fire started beneath the decking of the wharf or the floor of the waiting room.

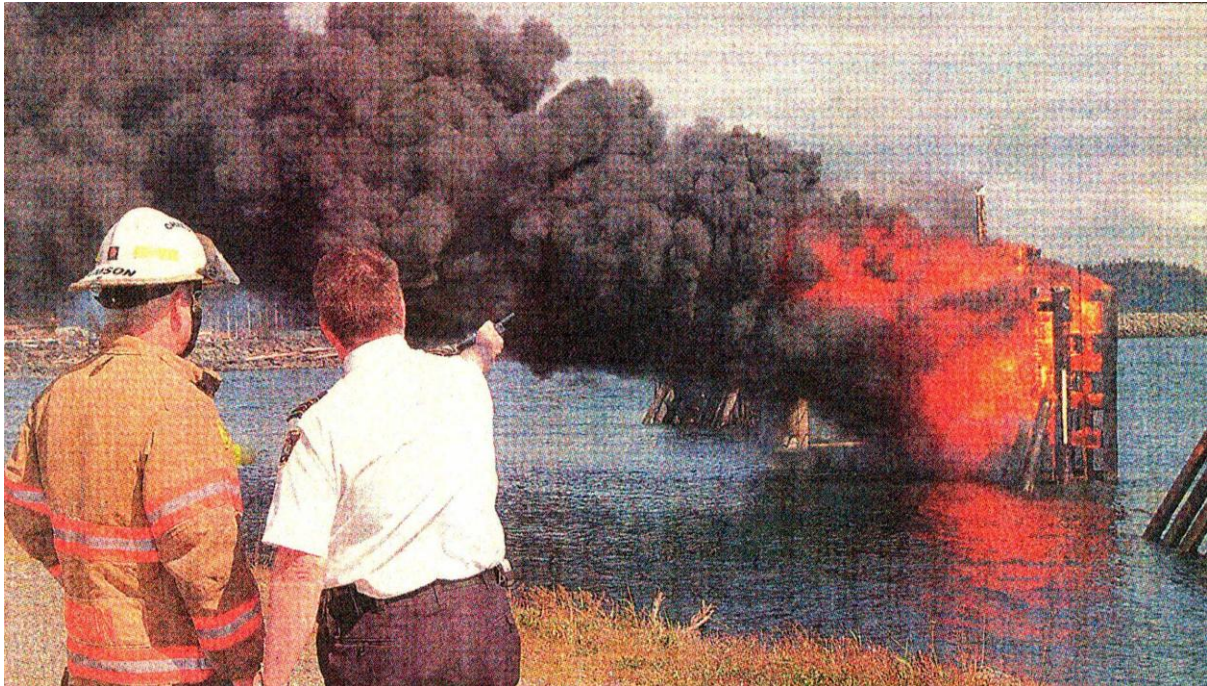
Figure 2

Another fire was reported at 11:15 a.m. on April 23 of 2007, at the Campbell River ferry dock that services the Quadra Island ferry (Figure 2). The fire occurred at a 'dolphin', a marine structure consisting of wooden piles driven into the ocean floor. This dolphin did not contain any electrical wiring, so an electrical cause was not possible.

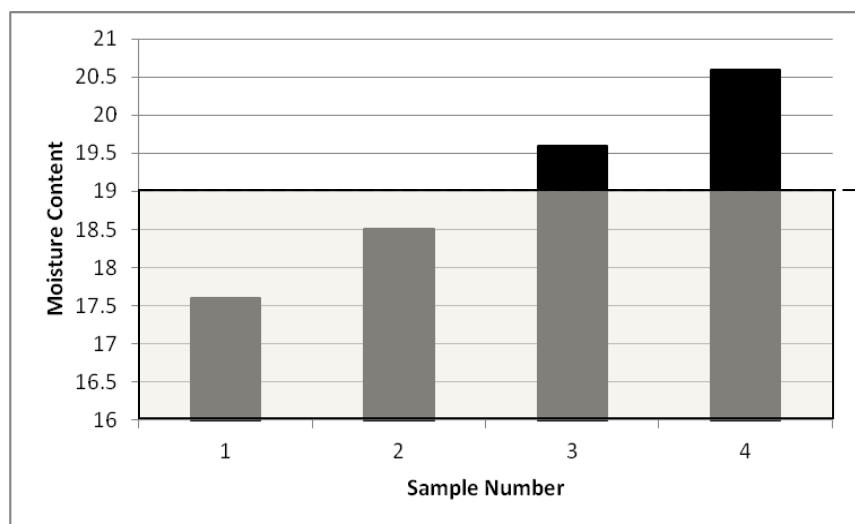
Figure 5

Testing showed that samples of well rotted wood with a moisture content of 19.6% and 20.6 % would ignite but not continue smouldering in still air. However, samples with moisture contents of 18.5% and 17.5% would ignite and smoulder until completely consumed. Therefore, for rotten wood from Douglas Fir to ignite and smoulder unassisted in still air, the moisture content must be approximately 19% or lower (Figure 5).

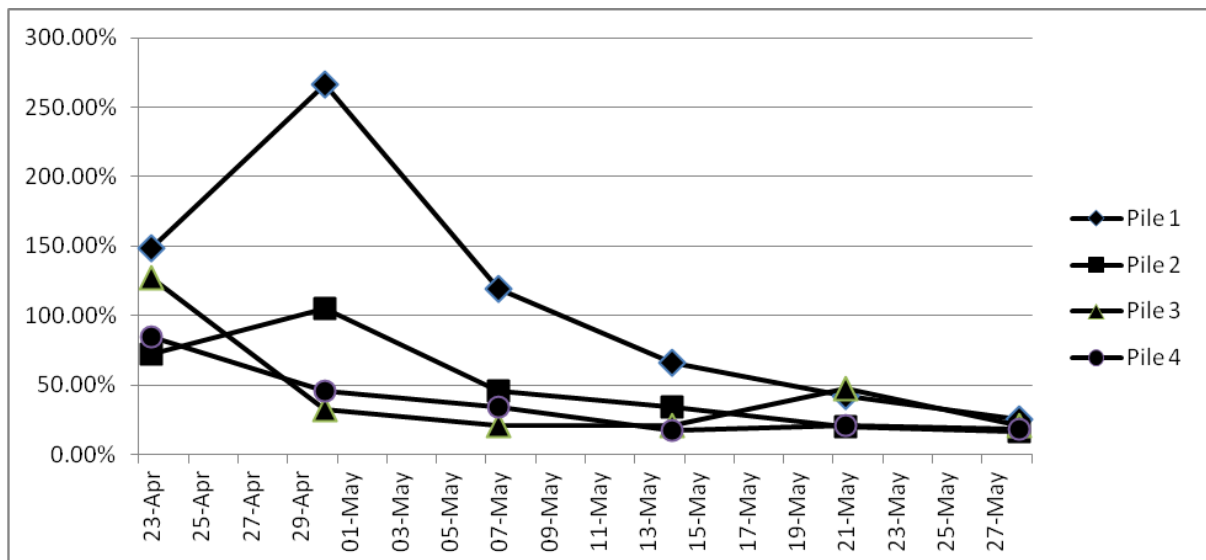
Figure 6

The moisture content of all four piles decreased at a similar rate. At the end of one month, the average moisture content of the piles was approximately 19%. The piles housed indoors and placed beside a de-humidifier dried at approximately the same rate as the piles left outdoors and in ambient wind conditions. Therefore, after saturation with water, rotten wood in marine pile tops reaches a moisture content level conducive to smouldering after approximately one month without rain (Figure 6).

The irregularity is due to moisture content differences in the pile tops. The rotten wood closest to the top tended to be the driest.

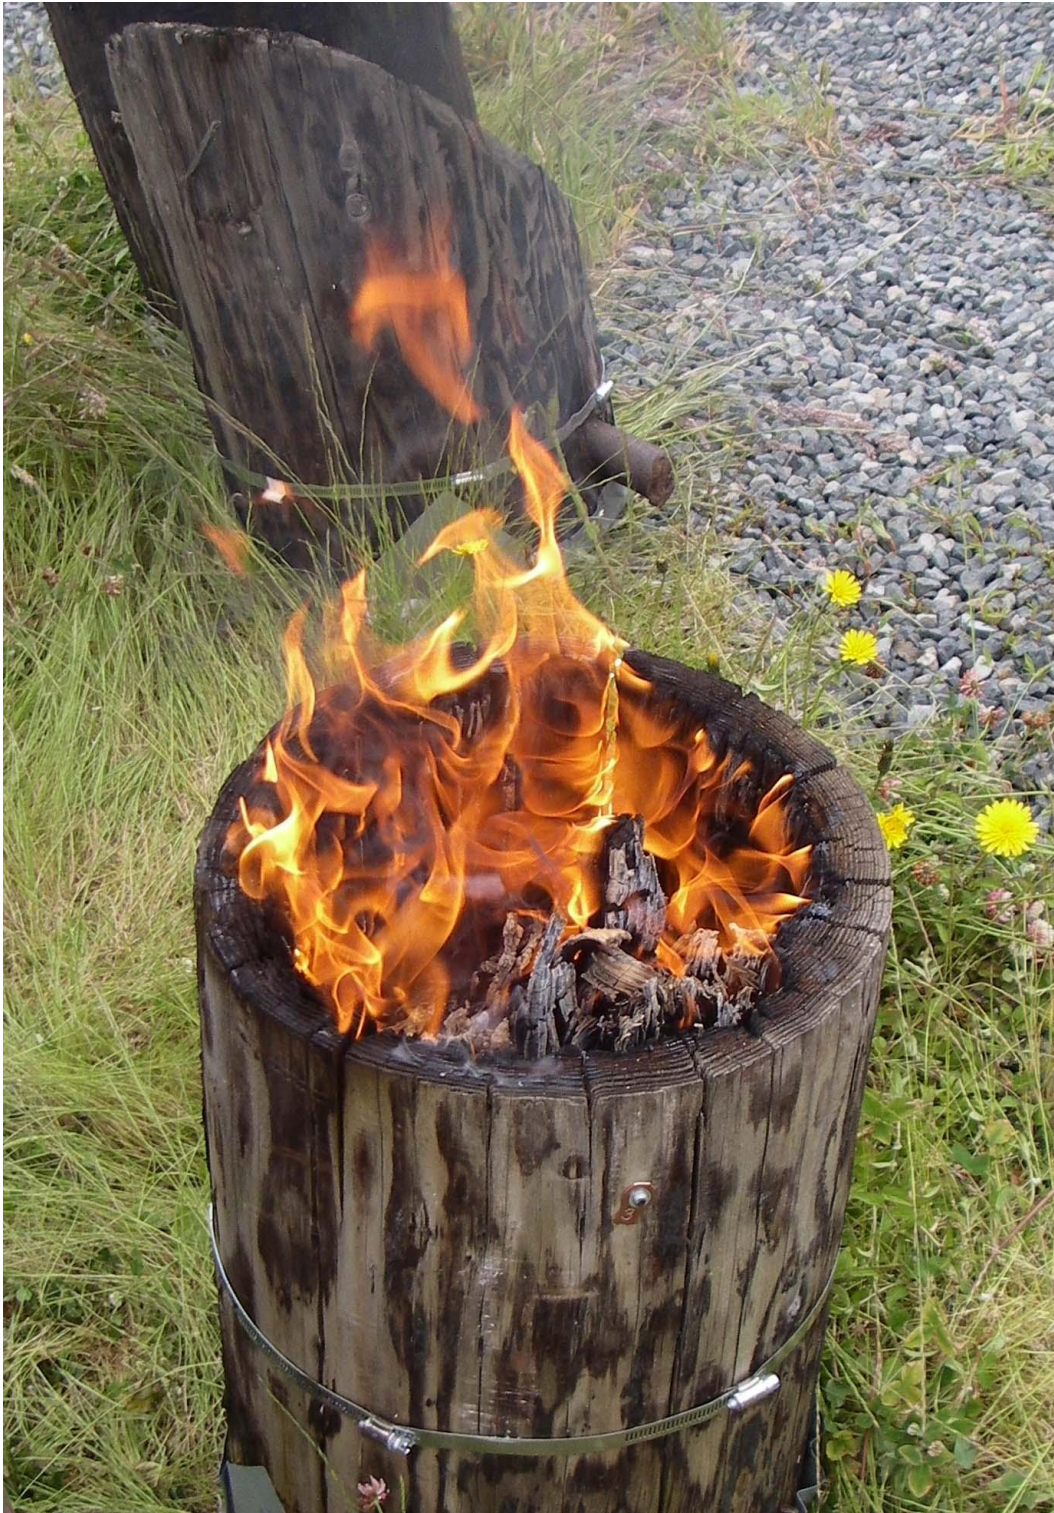
Figure 7

The four pile tops were taken to an area close to the Number 9 Fire Hall in Surrey, BC. The test was witnessed by many members of the fire hall. Three lit cigarettes were placed in the rotten wood in each of the four pile tops at approximately 9:45 a.m. At approximately 10:00 a.m. three of the four pile tops were noticeably smoking, and one transitioned from smouldering combustion to flaming combustion. At 10:19 a.m., the second of the four pile tops transitioned from smouldering combustion to flaming combustion. At 10:23 the third pile transitioned from smouldering to flaming combustion, and then returned to a smouldering condition. At 11:06, the fourth pile transitioned from smouldering to flaming combustion. At 11:20, the fires were extinguished. Therefore, in all four cases, cigarettes established smouldering combustion in the pile tops. The time taken for smouldering combustion to transition into flaming combustion in the four pile tops was 15 minutes, 34 minutes, 38 minutes, and 81 minutes. The variation in times is related to the distance from the point of origin of the smouldering to the pile top wall where a vertical surface allowed the transition from smouldering combustion to flaming combustion (Figure 7).

The most effective method to prevent fires from cigarettes contacting rotten wood on marine structures is to provide all piles with a metal hat to cover the top of the pile. The hat would tend to prevent rot and would act as a barrier to discarded cigarettes. Also, abandoned piles should be removed as they are not only a fire hazard but also cause damage when they break free. Piles made of non flammable materials should be considered for new construction to prevent fires and also to prevent marine pollution due to the creosote. Provision of fire-safe locations for smokers could be an option and smoking on marine structures made of wood should be discouraged.
