THE VULNERABILITY OF ROTTING MARINE STRUCTURES TO IGNITION BY DISCARDED CIGARETTES (THE 2003 SATURNA ISLAND WHARF FIRE)

Richard van Leeuwen PEng
van Leeuwen and Associates

Michael Fitz, PE
President and Principal, MDE Inc, Seattle, WA

Presented at the
13th International Fire and Materials Conference
2013 January 28 – 30
San Francisco, USA

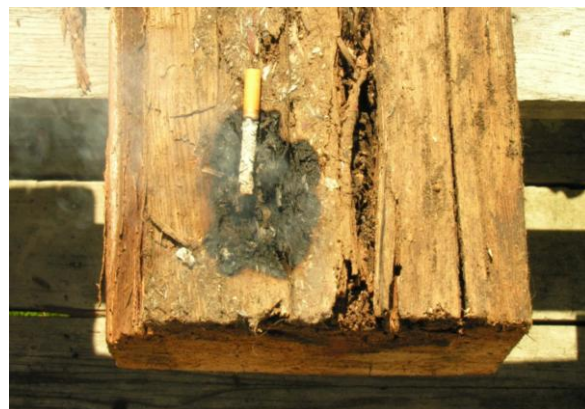
Figure 3

It was noted that the presence of wind increased the likelihood of ignition of a smouldering fire by a cigarette, and increased the rate of smouldering. All of the following tests (with the notable exception of the final test) were done under conditions without wind.

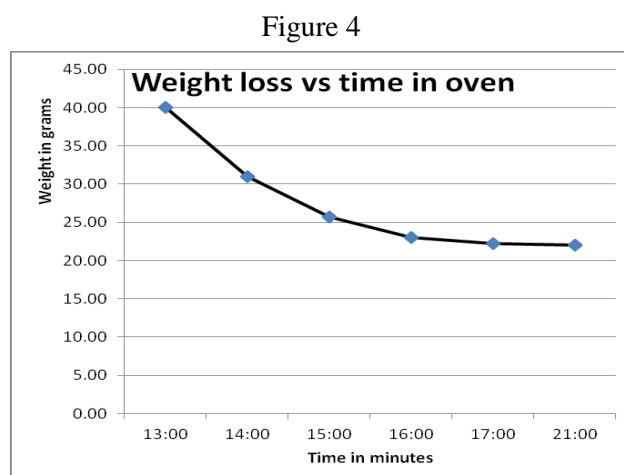
The moisture content and weight of a standard envelope No. 10 (105 mm by 245 mm) was measured and accounted for in the calculations. Samples of 20 to 40 grams of wood were put in the envelopes and the moisture content was measured after every minute. The weight stabilized after approximately 8 minutes. Consequently, a time of 10 minutes for drying the samples was used in all cases (Figure 4).
